CFI Bootcamp

Flight Instructor Training

Fuel Mismanagement

What happened and what should
have happened

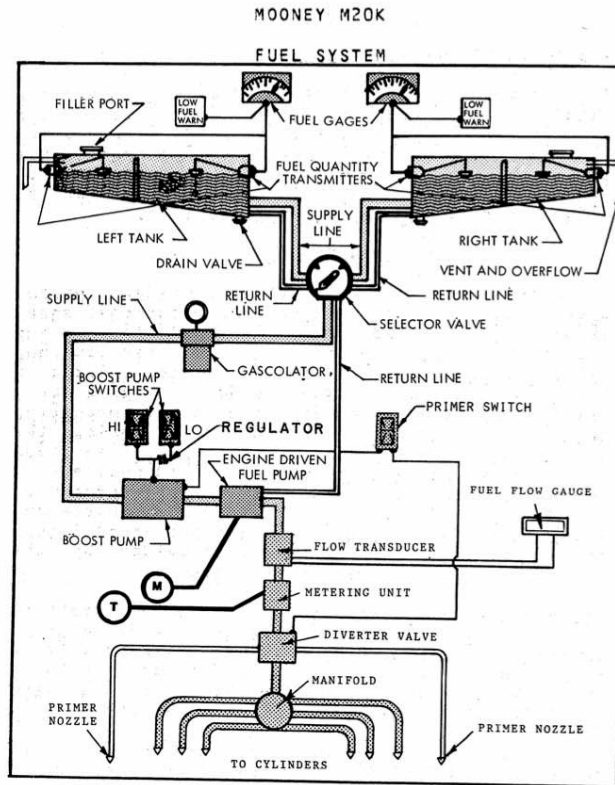
FIGURE 7-9

PROBABLE / ACTUAL CAUSE: Total loss of engine power due to fuel exhaustion. The pilot failed to ensure adequate fuel on board for the flight, likely departing with only 54 gallons for a route requiring up to 64.9 gallons at cruise power settings. He did not stop for fuel despite a 4.8-hour flight near the limits of his fuel load.

- **Calculate fuel endurance before every flight.** At 10–12.5 GPH, 54 gallons yields only ~4.3–5.4 hours. The pilot's planned route was nearly at the edge of that window with zero margin.
- **Use fuel totalizers as advisory tools only.** The Shadin MiniFlo must be manually reset at each fueling. An un-reset totalizer gives false confidence. Always cross-check with actual tank readings.
- **Apply the 45-minute VFR reserve rule.** 14 CFR §91.151 requires 30 minutes at night; conservative practice adds 45+ minutes. Plan fuel stops for long cross-countries.
- **Do not skip fuel stops to save time.** A 15-minute fuel stop is far preferable to a forced landing or worse.

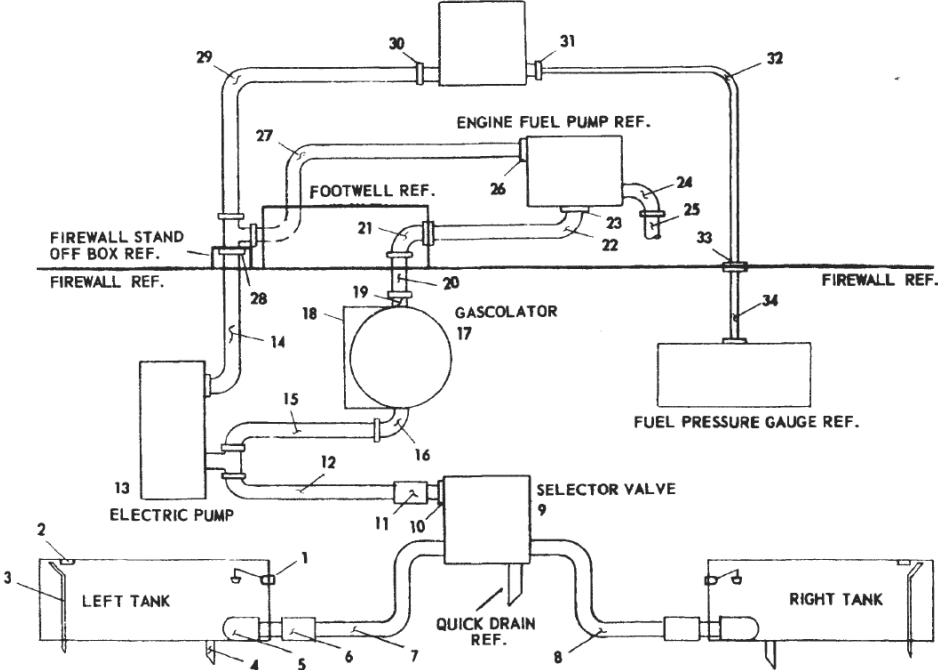
Case Study #2 – Fuel System

PROBABLE / ACTUAL CAUSE: Total loss of engine power due to fuel starvation. The pilot flew on one tank until it was exhausted without switching to the left tank, which still had 18 gallons. Task saturation from hand-flying in IMC without a functioning autopilot, combined with unfamiliarity with the aircraft's fuel system and the non-obvious floor-mounted fuel selector, contributed to the failure to switch tanks.

- **Get a thorough checkout before flying an unfamiliar aircraft.** The pilot had only one hour of ground instruction and one short flight in the M20B. A proper checkout includes in-flight fuel system practice.
- **Know where the fuel selector is located – and verify it.** The Mooney's selector is on the floor, painted black, unlike the red sidewall selectors in Pipers. Cockpit differences can be fatal.
- **Set a fuel-switching timer.** Switching tanks every 30–45 minutes prevents a single tank from running dry. Use the timer on your watch, EFB, or GPS.
- **Never rely on unfamiliar aircraft's fuel status assumptions.** If you are not certain how much fuel is on board, verify it visually – do not assume.
- **Manage workload before adding IMC.** Flying a new aircraft type in IMC without autopilot is extremely high-risk. Know your aircraft's systems thoroughly before filing IFR.

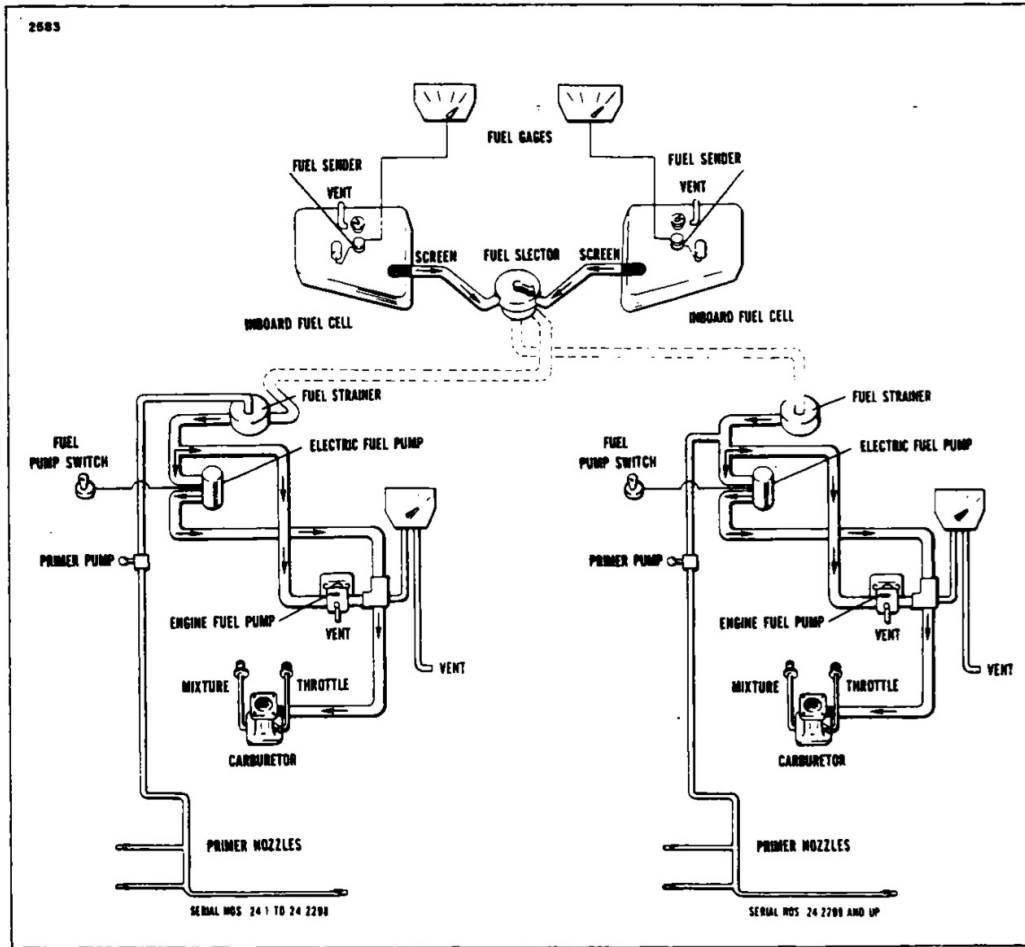
Case Study #3– Fuel System

PROBABLE / ACTUAL CAUSE: Total loss of engine power on takeoff due to fuel starvation from an empty selected tank. The pilot apparently did not conduct an adequate preflight check of fuel quantity or selector position. With only 2 weeks of ownership and no transition training documented in a complex four-tank aircraft, the pilot likely did not understand the fuel system or the importance of selecting the fullest tank for takeoff.

- **Always select the fullest tank for takeoff.** In multi-tank aircraft, the POH specifies which tank to use. Never depart on a tank showing near-empty.
- **Verify fuel quantity visually, not just by gauge.** Pre-flight photos showed the gauge near empty. The pilot either missed it or misread it. Dip the tanks or use a calibrated dipstick.
- **Get formal transition training in any new aircraft.** A Comanche with 4 tanks and a retractable gear is a significant step up. The pilot had no documented checkout in this airplane.
- **Scan all fuel gauges during the run-up checklist.** Before taking the runway, note both the quantity and the selector position for each tank as part of the before-takeoff checklist.

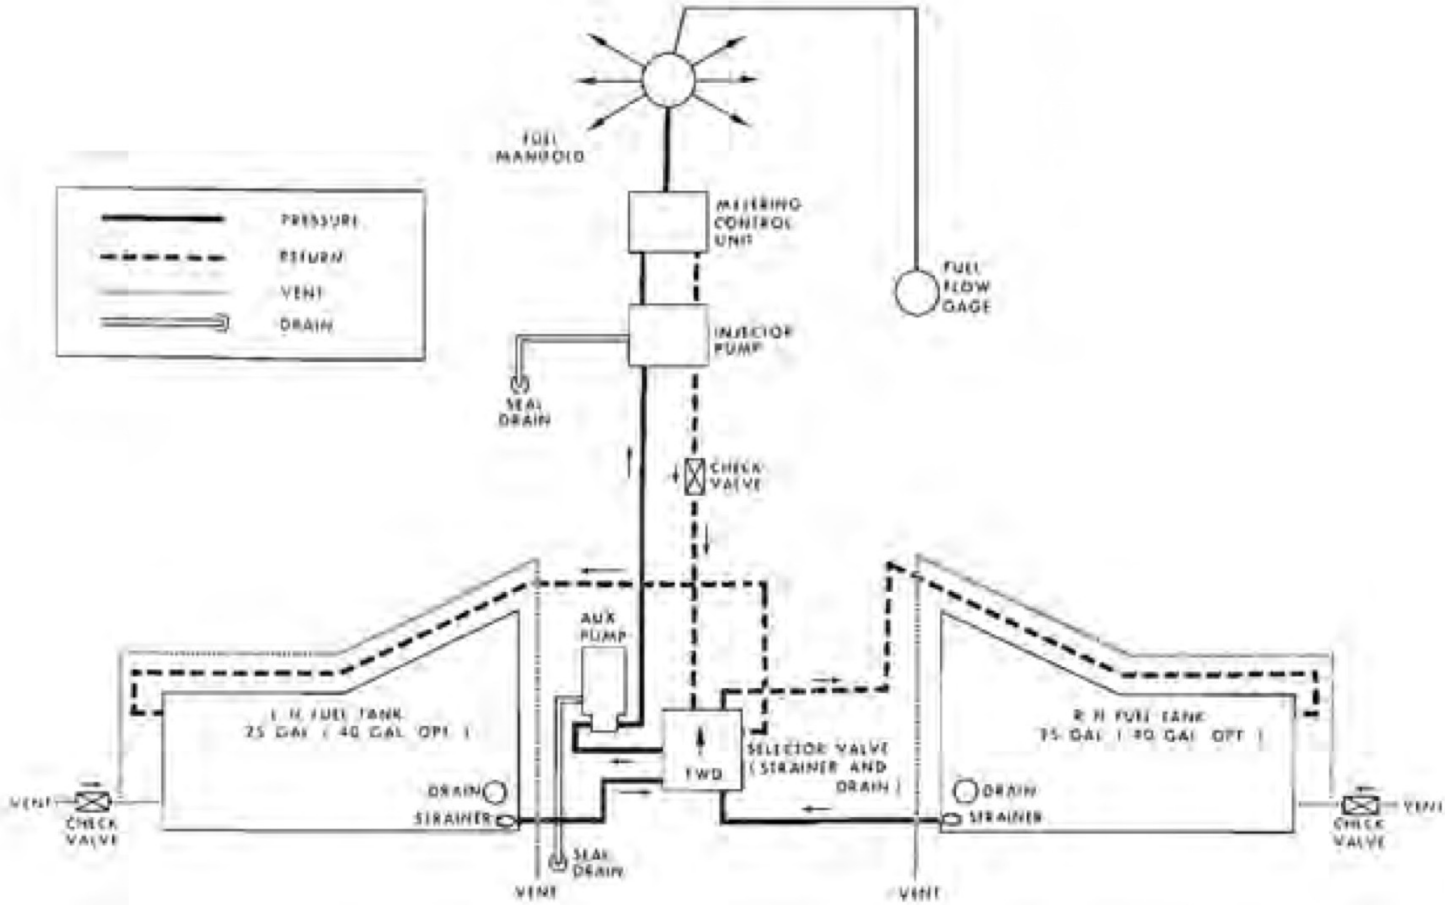
Case Study #4 – Fuel System

PROBABLE / ACTUAL CAUSE: Fuel exhaustion due to inadequate preflight fuel planning. Despite holding an ATP certificate and 21,764 hours, the pilot departed without verifying that sufficient fuel was on board for the flight. This case demonstrates that complacency — not inexperience — is the primary risk factor in fuel mismanagement accidents.

- **Experience does not prevent fuel mismanagement.** This ATP had 21,000+ hours and still ran out of fuel on an 8-minute flight. Complacency affects everyone. Always verify fuel before every flight.
- **Visually inspect every tank before every flight.** Do not assume the airplane has fuel from a previous flight. Tanks can leak; fuel can be drained; totalizers can be wrong.
- **Know your aircraft's complex fuel system.** The Bonanza 35-B33 has four tanks and separate pump controls for the wingtip tanks. Confirm all tanks are serviceable and selected correctly.
- **Confirm fuel quantity explicitly, even for short flights.** A 33 nm flight requires perhaps 10–15 minutes of fuel. But if the tanks are already near empty, even a short flight is fatal.

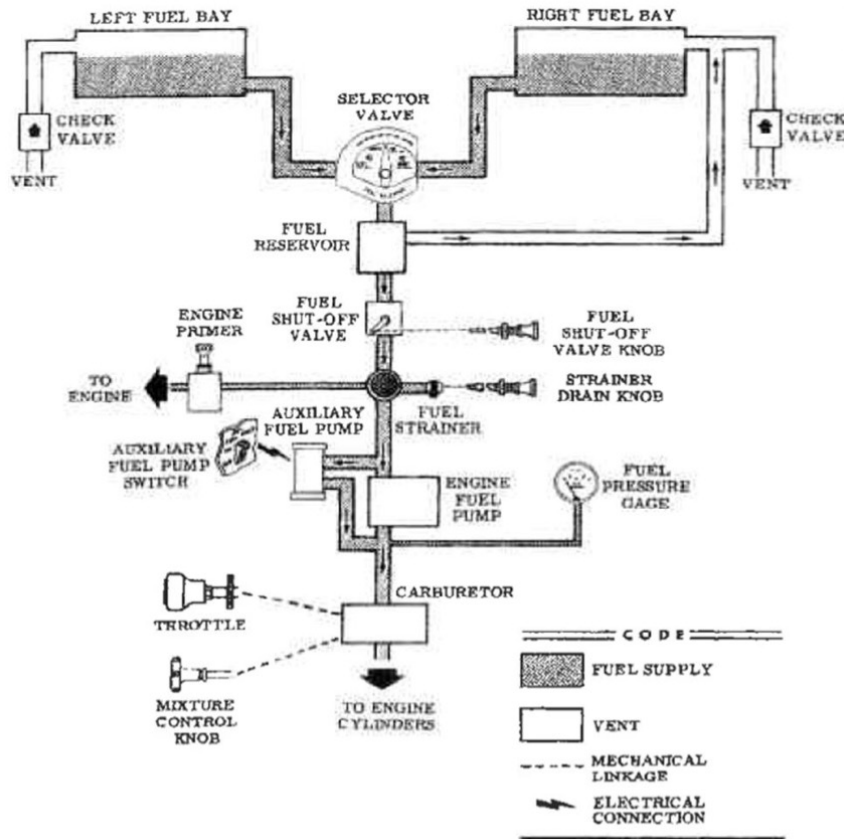
FUEL SYSTEM SCHEMATIC

PROBABLE / ACTUAL CAUSE: Partial loss of engine power due to fuel exhaustion. The pilot's fuel calculations were inaccurate, resulting in the aircraft running out of fuel before reaching the destination. Contributing factors may have included inaccurate fuel gauges, failure to track actual fuel burn, and possible carburetor icing compounding the issue during descent.

- **Track fuel burn in flight, not just at preflight.** Use a fuel flow meter or EFB to monitor actual consumption vs. planned. Cross-check gauges every 30 minutes.
- **Don't trust the gauges alone.** FAA regulations require fuel gauges to be accurate only when reading 'empty.' Never plan a flight assuming the gauge reading is precise.
- **Apply carburetor heat early in descent.** In carbureted engines, apply carb heat before reducing power in descent, especially in conditions favorable for icing (high humidity, temperatures between -10°C and +20°C).
- **Land with a fuel reserve — always.** Plan to arrive with at least 45 minutes of fuel remaining. If your math shows you'll arrive with 10 gallons, plan a fuel stop before departure.
